Manhole Inspection Summary

Manhole # S29E__058MH

Insp Date: **10/1/08 7:34 AM**

Location Address: **222 N Pine**

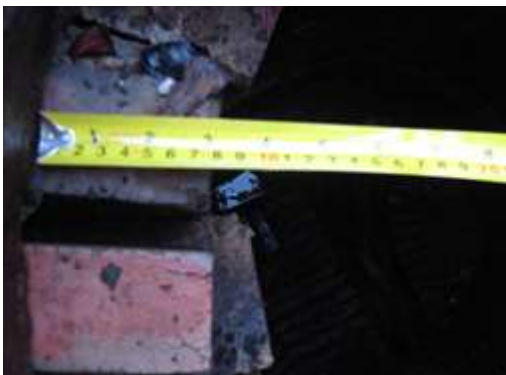
DEfect 2

Frame Offset: **3.5** (in.) Condition: ☐ Sound ☐ Cracked ☒ **Leaks**

offset 3.5 inches

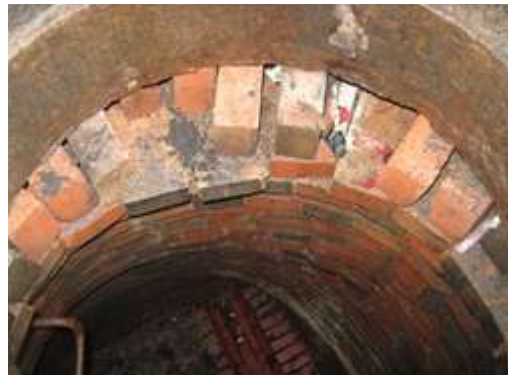
Defect 1

Condition: ☐ Sound ☐ Cracked ☐ Root Intrusion ☒ **Loose Brick** ☒ **Deteriorated**

Infiltration: ☐ None ☐ Joint ☐ Cracks ☒ **Mortar** ☐ Roots ☐ Wall

loose bricks and missing mortar

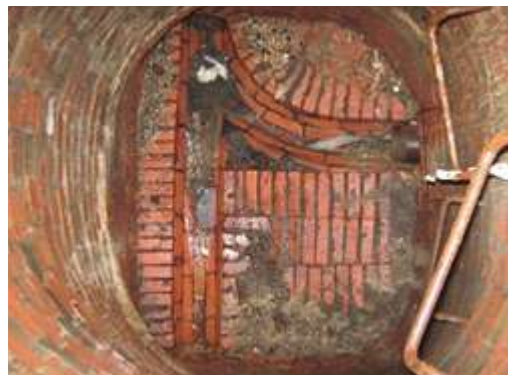
DEfect 4

Steps Count: **4** Missing: **0** ☒ **Corroded**

corroded steps

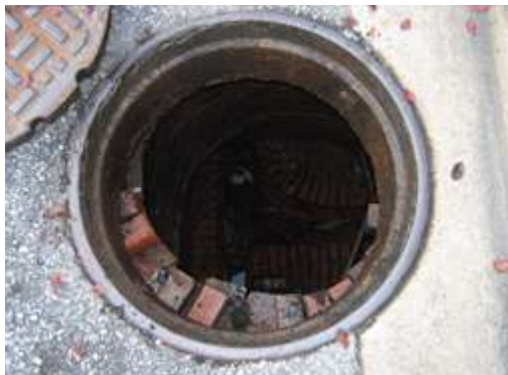
DEfect 3

frame leaks

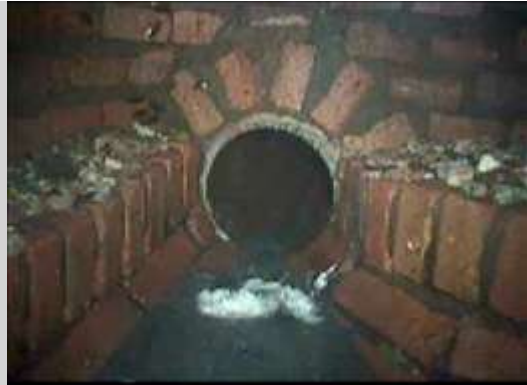
12 O'Clock Outflow

8 in. Circular Gravity Sewer
Pipe Out @ 12 O'Clock

Pipe Height: **8.4** (in.) Rod and Bar (Angled)
Pipe Material: **Clay** ☐ Pipe Lined
Invert Depth: **9.32** (ft.) Flow Characteristics: **Slow**
Deposits: ☒ None ☐ Mud ☐ Sludge ☐ Debris ☐ Grease
Silt Depth: **0** (in.) Deposits Extent:
Infiltration: **None** Pipe Seal Cond: **Sound**

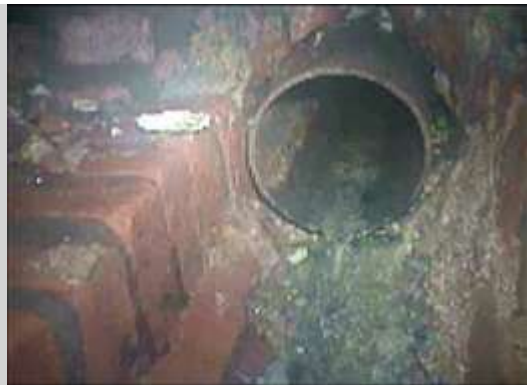
2 O'Clock Inflow

6 in. Circular Gravity Sewer
Pipe In @ 2 O'Clock

Pipe Height: **6** (in.) Rod and Bar (Angled)
Pipe Material: **DIP/CI** ☐ Pipe Lined
Invert Depth: **8.43** (ft.) Flow Characteristics: **Slow**
Deposits: ☒ None ☐ Mud ☐ Sludge ☐ Debris ☐ Grease
Silt Depth: **0** (in.) Deposits Extent:
Infiltration: **None** Pipe Seal Cond: **Sound**

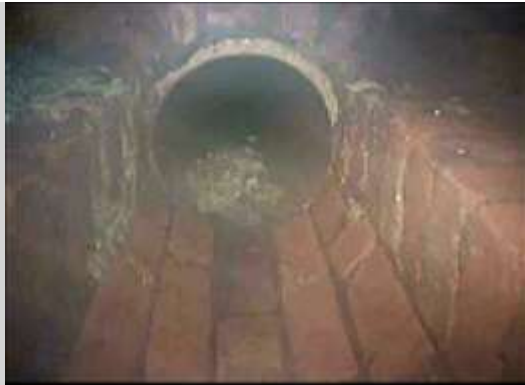
6 O'Clock Inflow

8 in. Circular Gravity Sewer
Pipe In @ 6 O'Clock

Pipe Height: **8.4** (in.) Rod and Bar (Angled)

Pipe Material: **Clay** ☐ Pipe Lined

Invert Depth: **9.20** (ft.) Flow Characteristics: **Slow**

Infiltration: **None** Pipe Seal Cond: **Sound**
